Japan's Tonen Corp. Solves Refinery Corrosion Problems with APC's ChemLine®

ChemLINE®
CASE STUDY

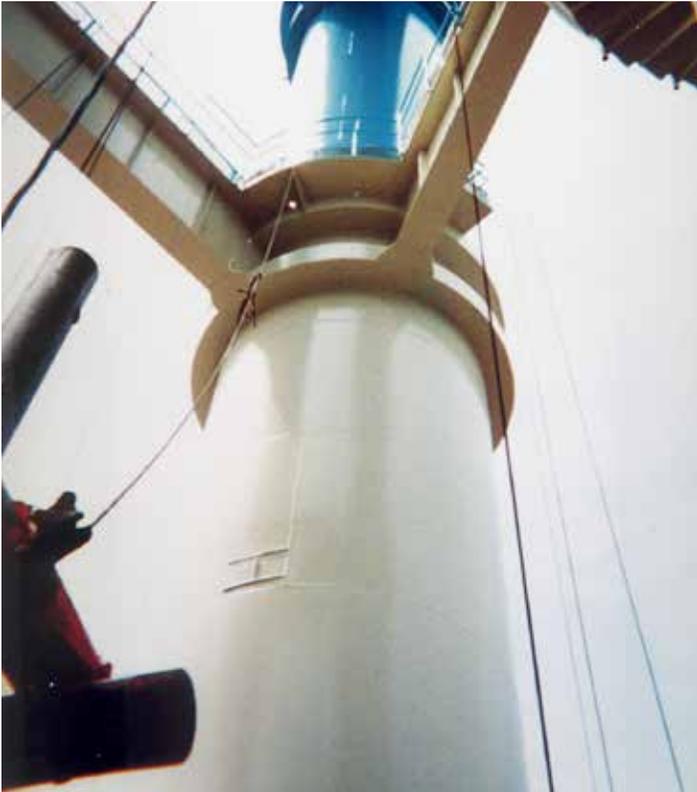
Closeup of coating on stack.

Tonen also utilized another feature of the ChemLine® coating – its ability to be pigmented in various colors. At the Tonen refinery, earth colors were used to blend in with the surrounding natural environment. For example, pipes located by the beach were coated with a sand color. Stacks were coated white at the base and progressively tinted with blue as the stack rises. At the top of the stack the color became darker blue to blend in with the sky.

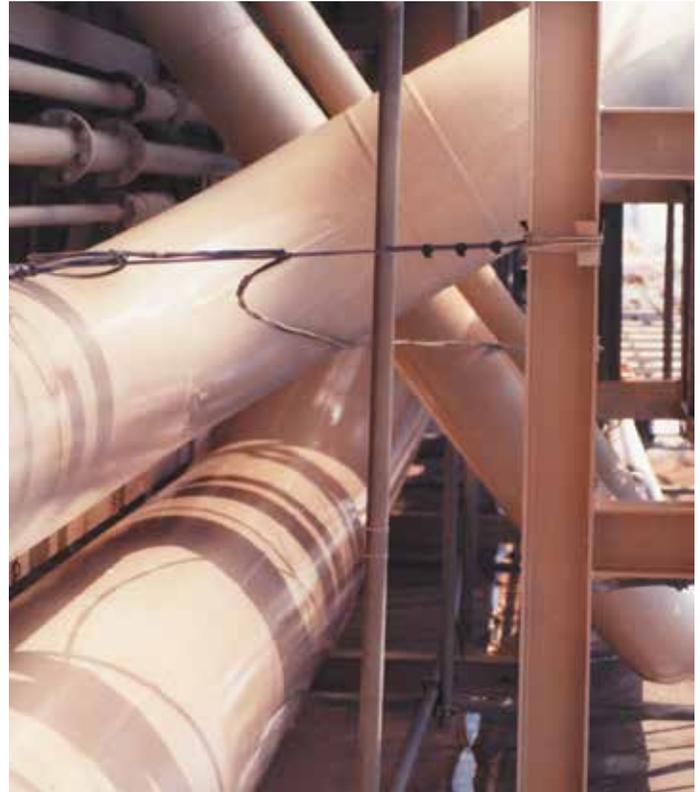
Pipe running throughout Tonen facility is coated with ChemLine®.

To conform to environmental guidelines and close monitoring from local government officials, Tonen carefully prepared the pipe and steel structures for the new coating application. First, all structures with well-bonded paint were high pressure washed with water containing a biodegradable detergent to remove dirt, grease and grime. Next, to avoid any sandblasting, any areas with loose rust were removed by mechanical brush with vacuum collection. Finally, all deteriorated paint was removed from the structures by mechanical means and vacuum collected.

Once all surfaces were ready, the ChemLine® coating was applied in two separate 3-4 mil coats (75 to 100 microns). This guaranteed complete encapsulation of the lead based paint. The coating was even applied over hard rust without surface preparation.
