# ChemLine® Coating Protects Stainless Steel Reactor Against Saponification Reaction

**ChemLINE®**  
CASE STUDY

At the Alimentos Polar Comercial Planta Limpieza, in Valencia, Carabobo Estate, Venezuela, the stainless steel clutcher reactor tank needed protection against chemical attack and surface erosion due to the saponification reaction.

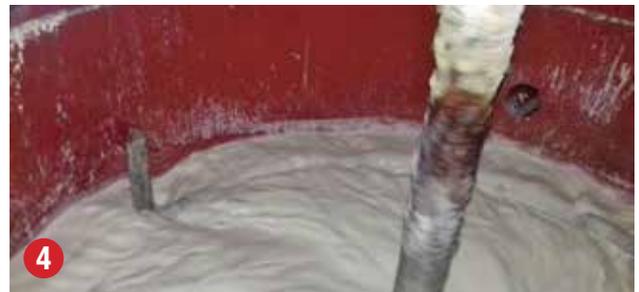
4

- 1) Bare stainless steel reactor tank prior to coating with ChemLine®. Previously, the turbulent mixing during saponification reaction process wore down the bare stainless steel tank material and caused pitting.
- 2) The tank is now lined with the protective ChemLine® system and ready for service.
- 3) The tank cap is also coated with ChemLine®.
- 4) Showing the mixing process in action.
- 5) After mixing, an empty tank is shown, with the ChemLine® tank coating in excellent working condition.
