## ChemLine® Coatings Deliver Excellent Corrosion Results at Coal-Fired Plant

## **EREN ENERGY (Eren Enerji)**

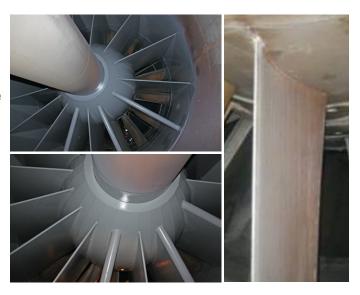
(Left) Close up of booster fan coated with ChemLine® 2400/32 protection. (Right) Close-up inspection of fan blade coated with ChemLine® shows excellent performance against corrosive flue gas/chemical service conditions.

Earlier this year, the Eren Energy coal-fired power plant in Turkey had two carbon steel booster fans in flue gas desulfurization (FGD) stacks coated. One of the fans was coated with Advanced Polymer Coating's ChemLine® 2400/32 and the other fan with a competitor's coating. The main objective of the booster fans is to increase flue gas pressure to promote flow through the ducts and to the top of the chimney.

Both of the carbon steel fans that were coated were exposed to the same corrosive flue gas/chemical service conditions. According to a report from Eren Energy, the high-performance ChemLine® coating performed as expected and the coating continues to provide service. However, the competitor's coating was virtually destroyed and now needs to be replaced. Eren Energy has specified the ChemLine® 2400/32 system for this other booster fan as they are very pleased with the coating's performance.
